DOWN THE TOILET

Western Washington University

Water Assessment

By Bob Sabie and Travis Mabee

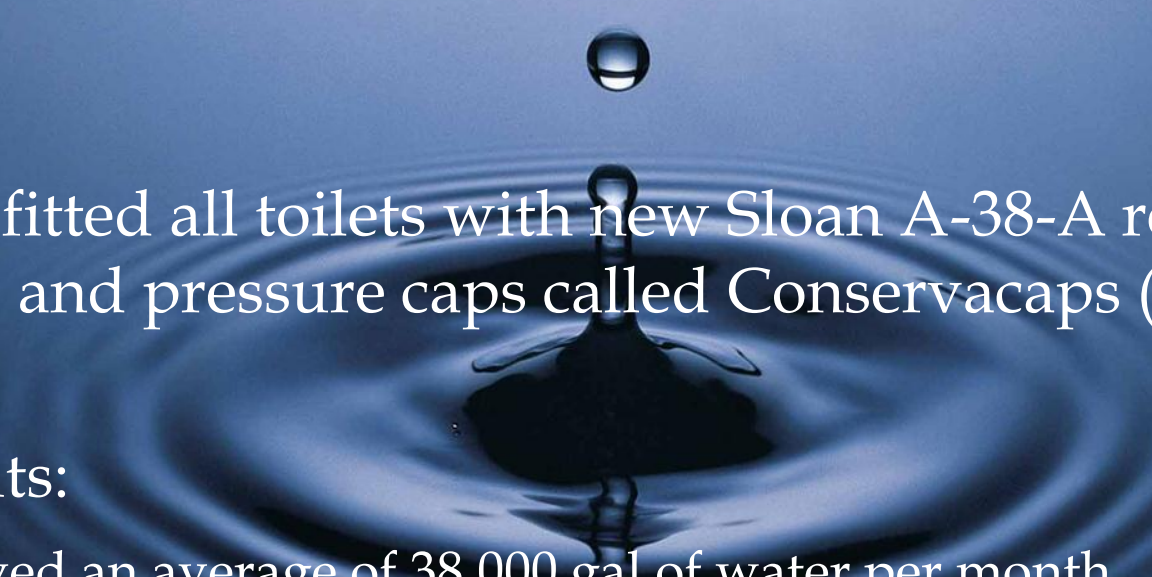
Sloan A-38-A repair kit & Conservacap

- 146 pre 1971 Sloan Flushometers using a min. of 3.5 GPF.
 - Retrofitted all toilets with new Sloan A-38-A repair kits (\$ 12) and pressure caps called Conservacaps (\$ 13).
 - Results:
 - Saved an average of 38,000 gal of water per month.
 - Saved ~ \$305.90 a month and ~ \$3670.80 a year.
 - Cost of retrofit was \$3,650. Return on investment ~ 1 yr.

- Trial run of Sloan A-38-A retrofit kit and Conservacap
 - Weekly monitoring system
 - Sub-meter installation on new buildings and all renovations
 - Continued assessment of water savings potential
-

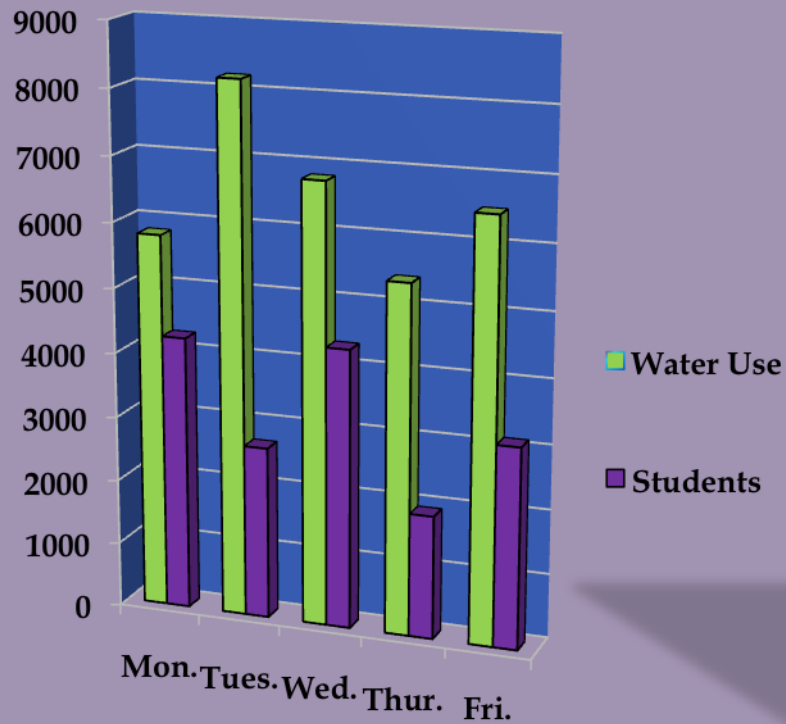
CF DAILY WATER USE (GAL) & STUDENT ENROLLMENT

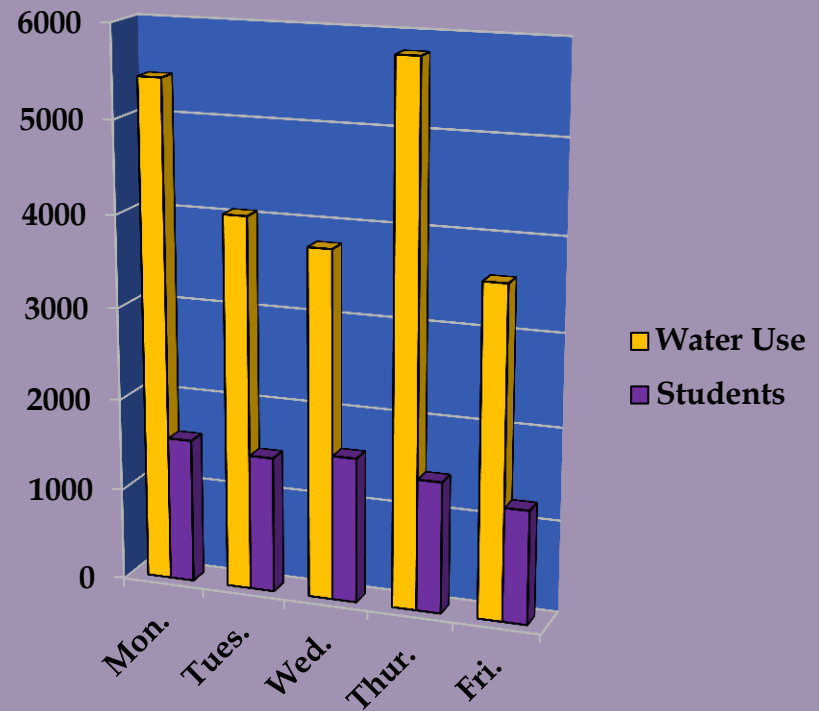
ES DAILY WATER USE (GAL) & STUDENT ENROLLMENT

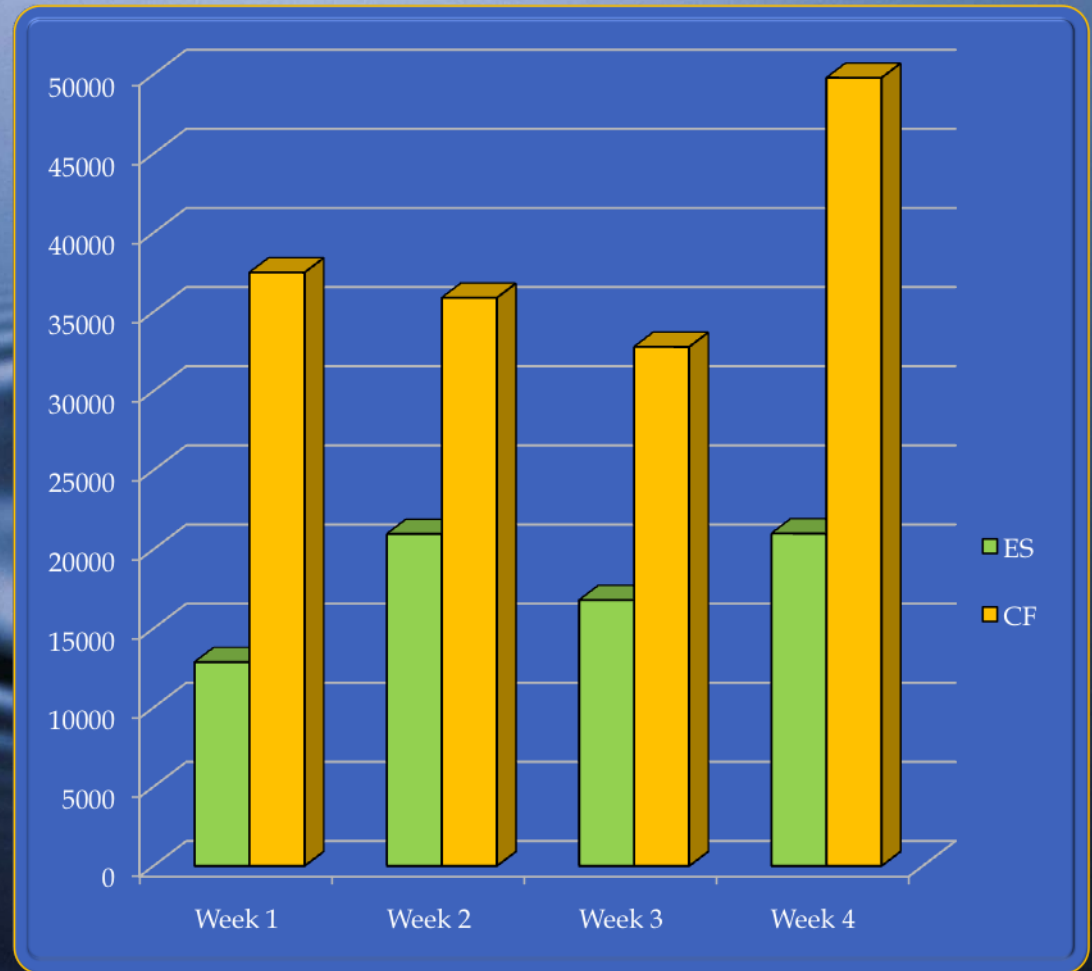
- Average weekly water use for ES was ~ 17,000 gal.
- Average weekly water use for CF was ~ 34,000 gal.
- Weekly averages had high variations.

FEB. WATER CONSUMPTION (GAL)
OF ES & CF
